**CAMP RISING SUN
FACILITIES EVALUATION REPORT
TOWN OF RED HOOK, DUTCHESS COUNTY, NY**

PREPARED BY
Crawford & Associates Engineering, P.C.
4411 Route 9, Suite 200
Hudson, New York 12534

PROJECT NUMBER
4651.00

PREPARED
DECEMBER 23, 2015

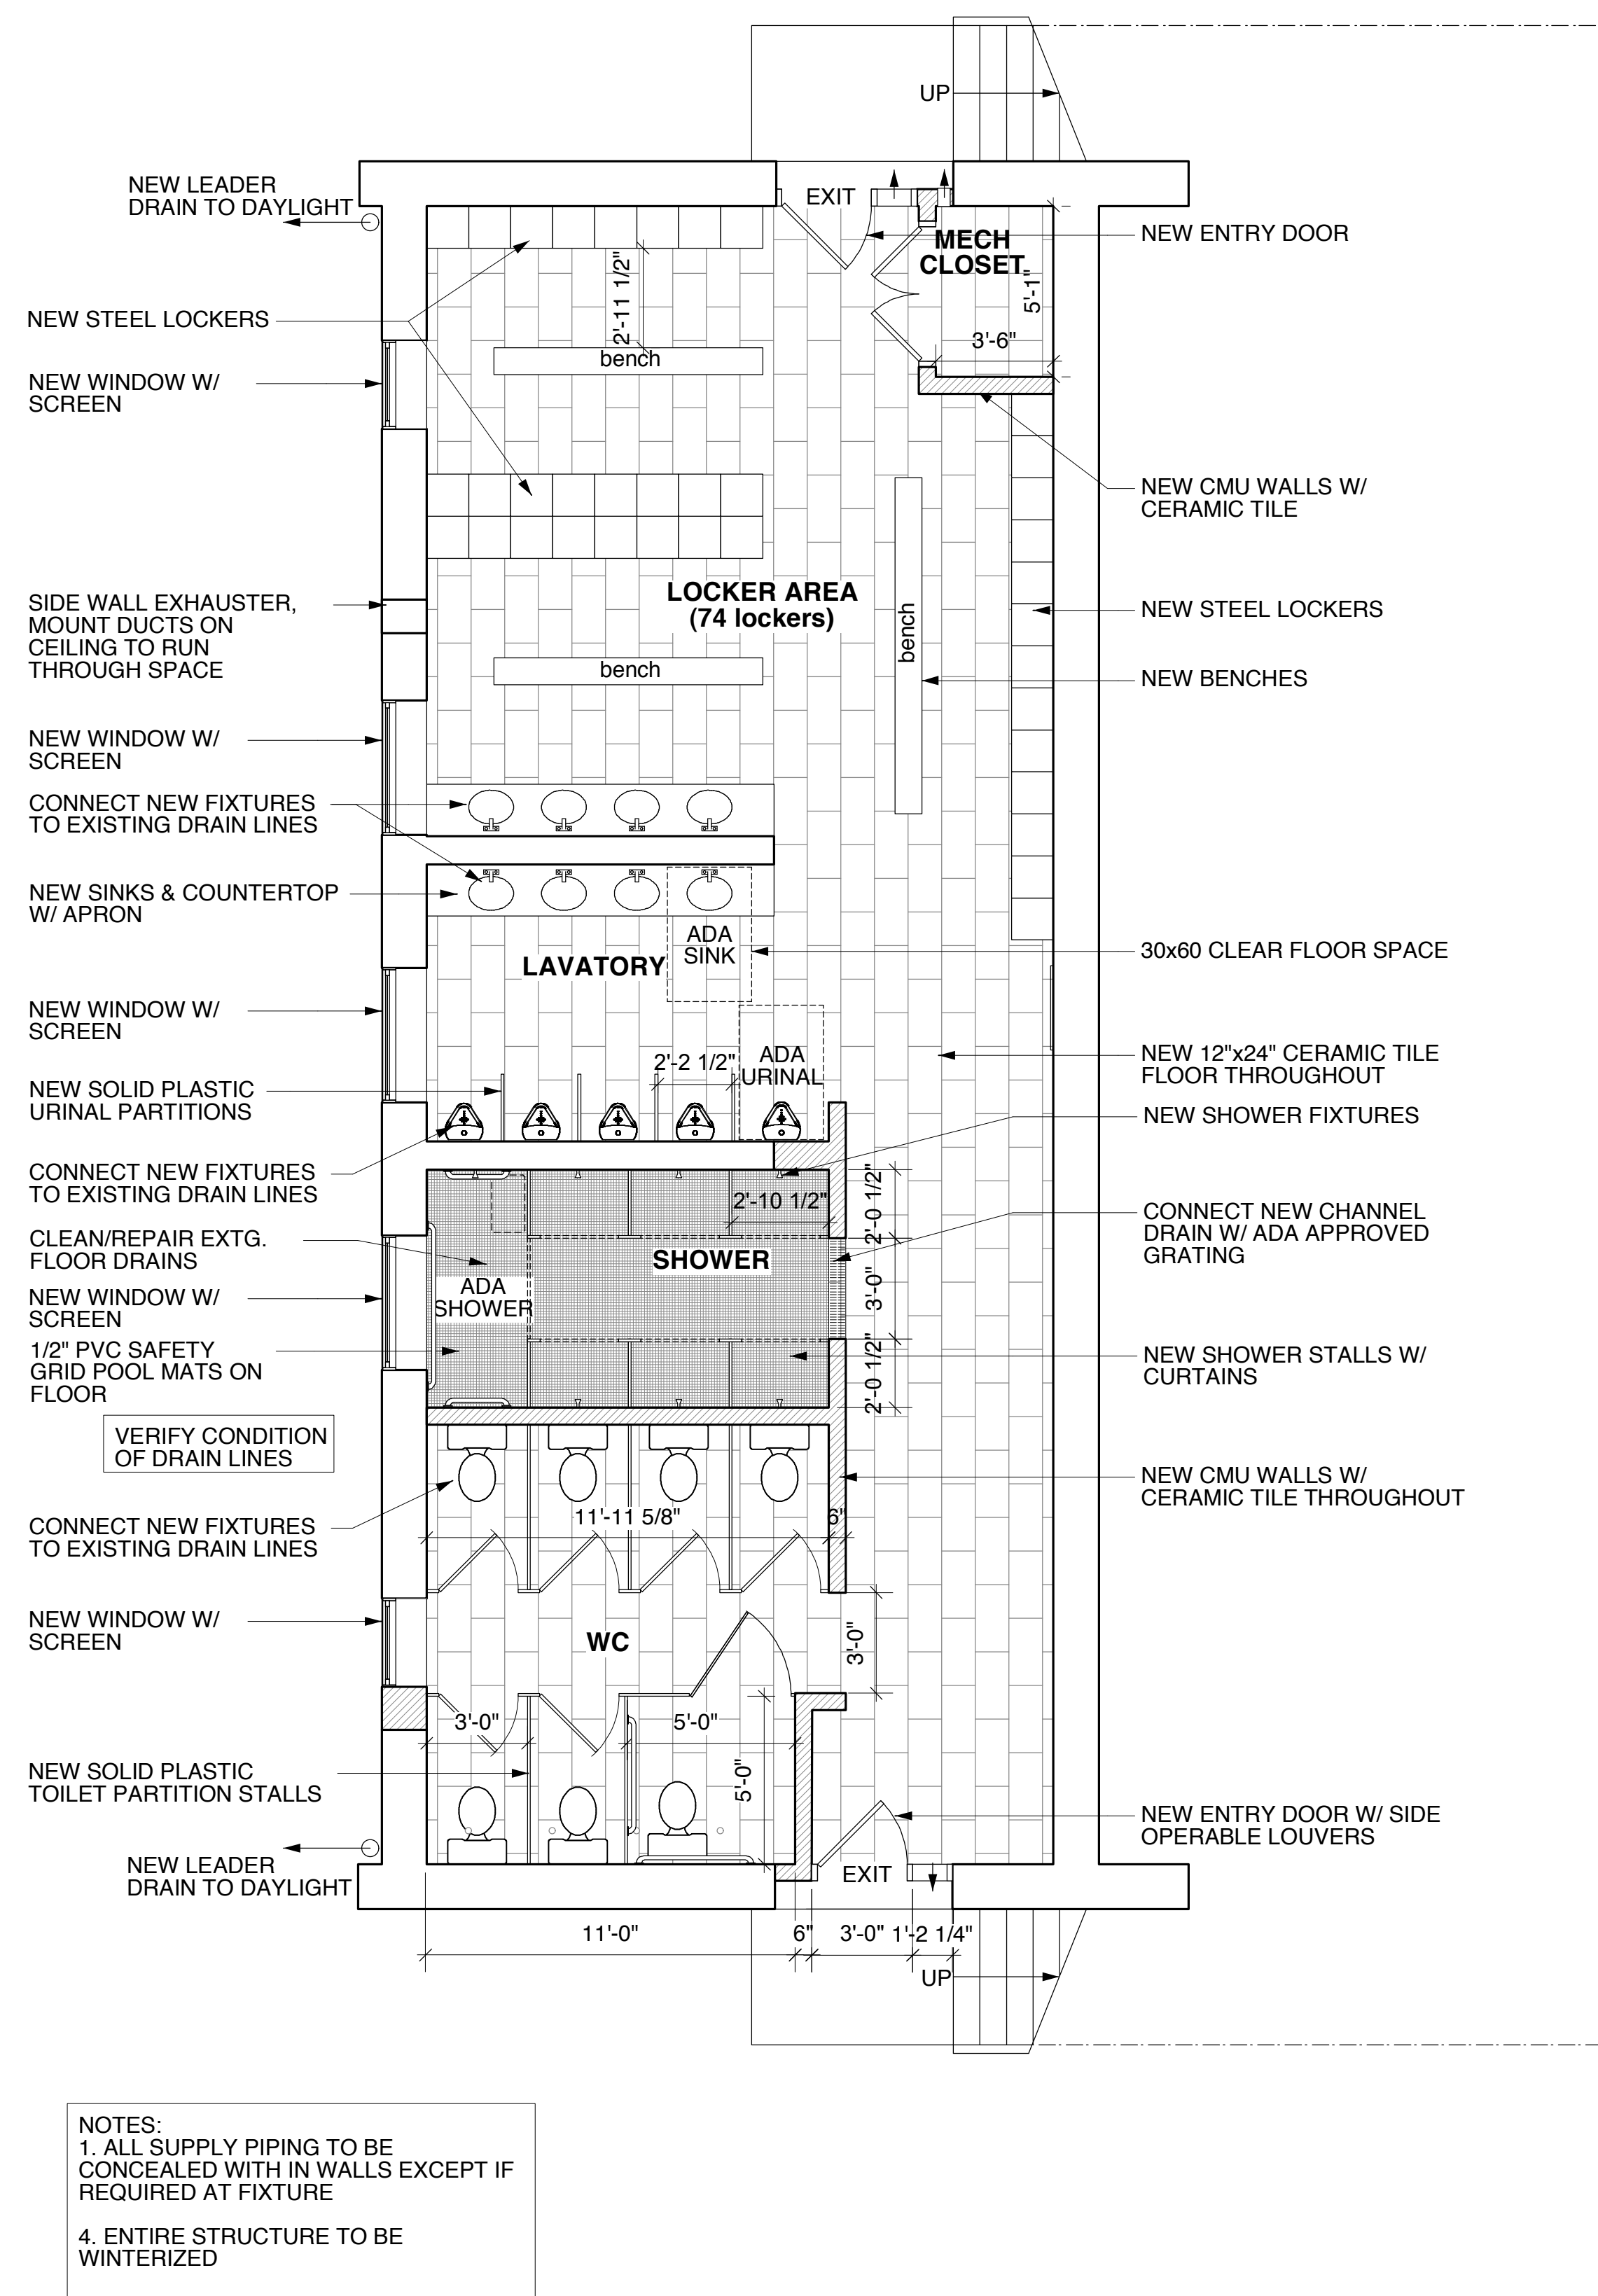
DRAWING TITLE
BASEMENT PLAN

- The existing condition of the lower level is generally in very poor condition. The plumbing is improperly installed, damaged and not located per Code.
- There are signs of mold and mildew throughout indicating insufficient ventilation and improper setting and sealing of material throughout.
- The exterior doors and louvers are decayed and not weatherproof
- The window screens are damaged and rotting
- The tile floors is no longer suited for usage.
- Concrete block walls have evidence of moisture damage and mold.
- The mechanical equipment is exposed and not properly housed. (water heater, pressure tank, water supply, etc.)
- The ventilation system is insufficient for the moisture control of the space.
- The lockers are in very poor shape and have exceeded their useful life

- It is recommended that the entire lower level be redesigned and reconstructed to comply with code and best building practices. See attached plans in Appendix 2.
- New tile floors should be installed throughout with drainage mat.
- Concrete block walls need repair and or replacing. Properly sealed tile walls should be installed throughout.
- Existing windows and frames require replacement with new windows and screens.
- A mechanical room is required to store all equipment. The obsolete pump and water tank should be removed.
- The design and installation of a proper ventilation system will be required.

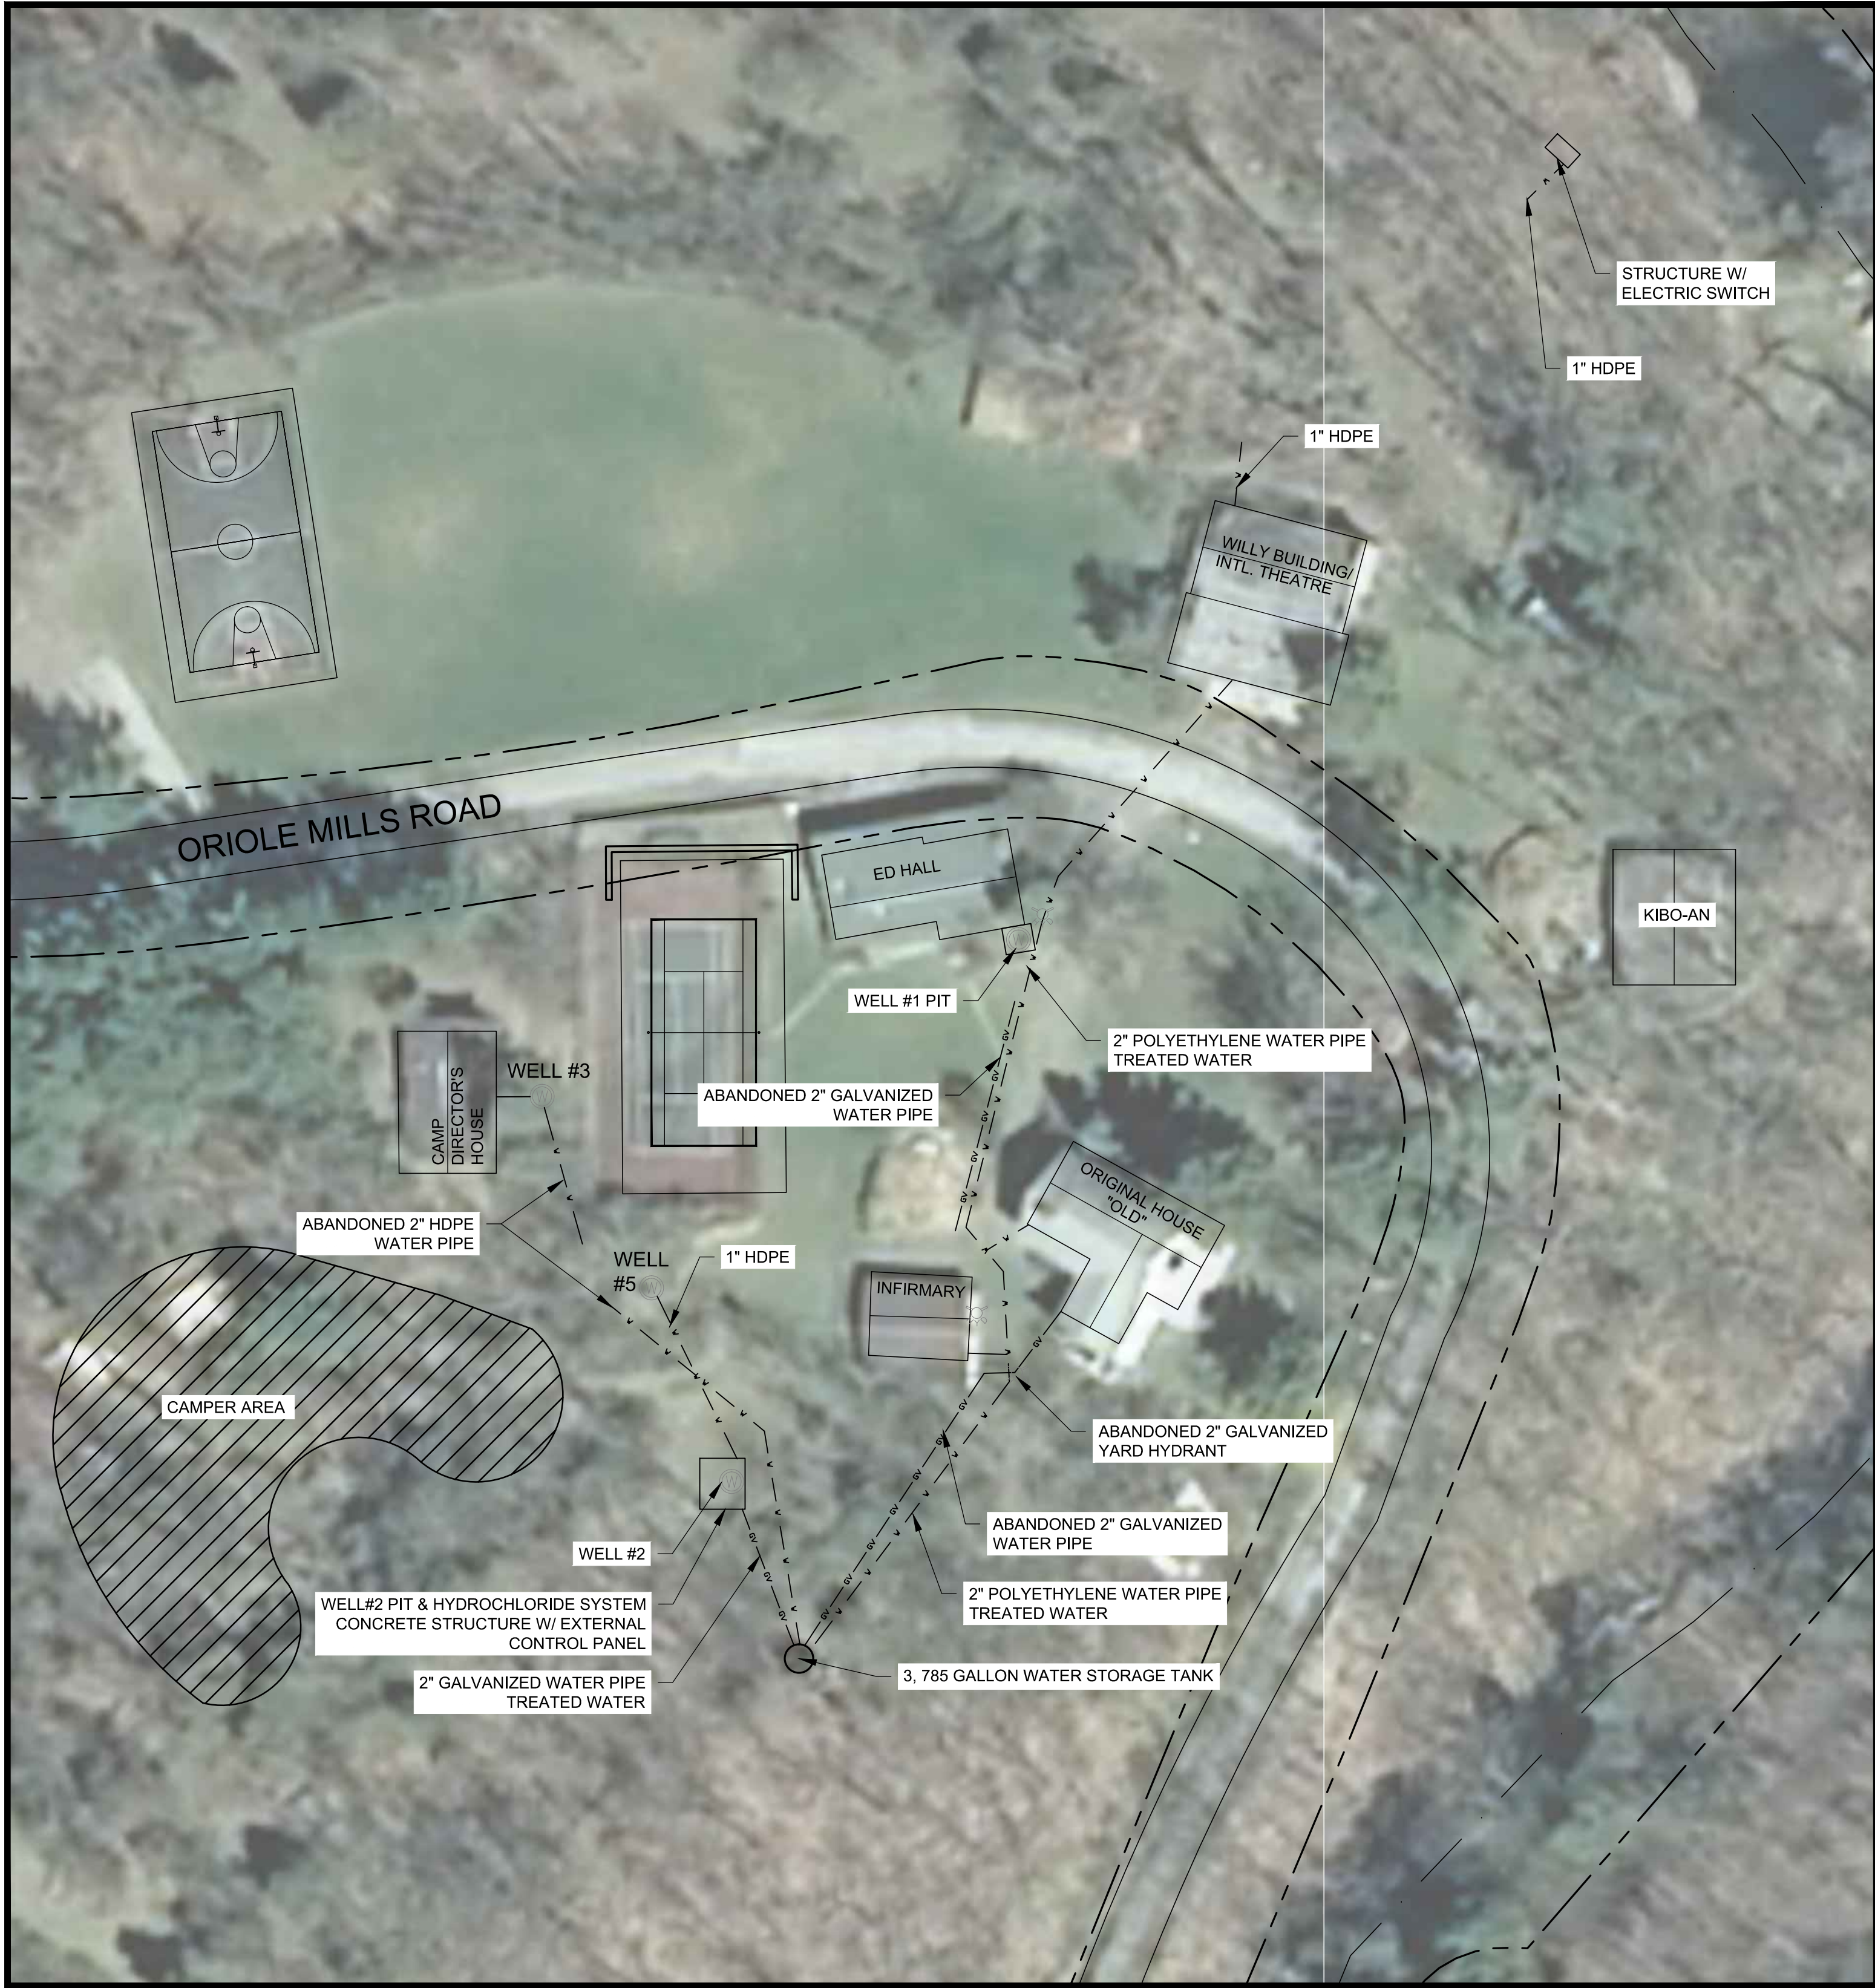
SCHEMATIC EXISTING CONDITIONS
SCALE 1" = 40'

- a. Many of the abandoned water piping (2" galvanized) and yard hydrants has been left onsite.
- b. DCHD noted that the water piping at the water storage tank was confusing and a mix of different pipe types.

- c. Water from the well house is sent through a 2" galvanized pipe to a 2" PVC Schedule 40 pipe to the water storage tank. This run of pipe also has a shutoff valve located at the tank. This pipe was noted as not connected to the water storage tank at this time. This system is winterized via disconnection.

- a. Water storage tank is made out of wooden boards and is roughly holds 3, 785 gallons. The interior of the tank includes a PVC liner. Water storage tank is equipped with a 2" PVC Schedule 40 overflow pipe leading south of the tank.
- b. DCHD commented on the water storage needs to be inspected for regulatory compliance.
- c. The tank lacks proper enclosure and screened openings to prevent birds and animals from accessing the tank interior. This is a Code violation.
- d. The well house includes the tank alarm panel and controls for the storage tank.

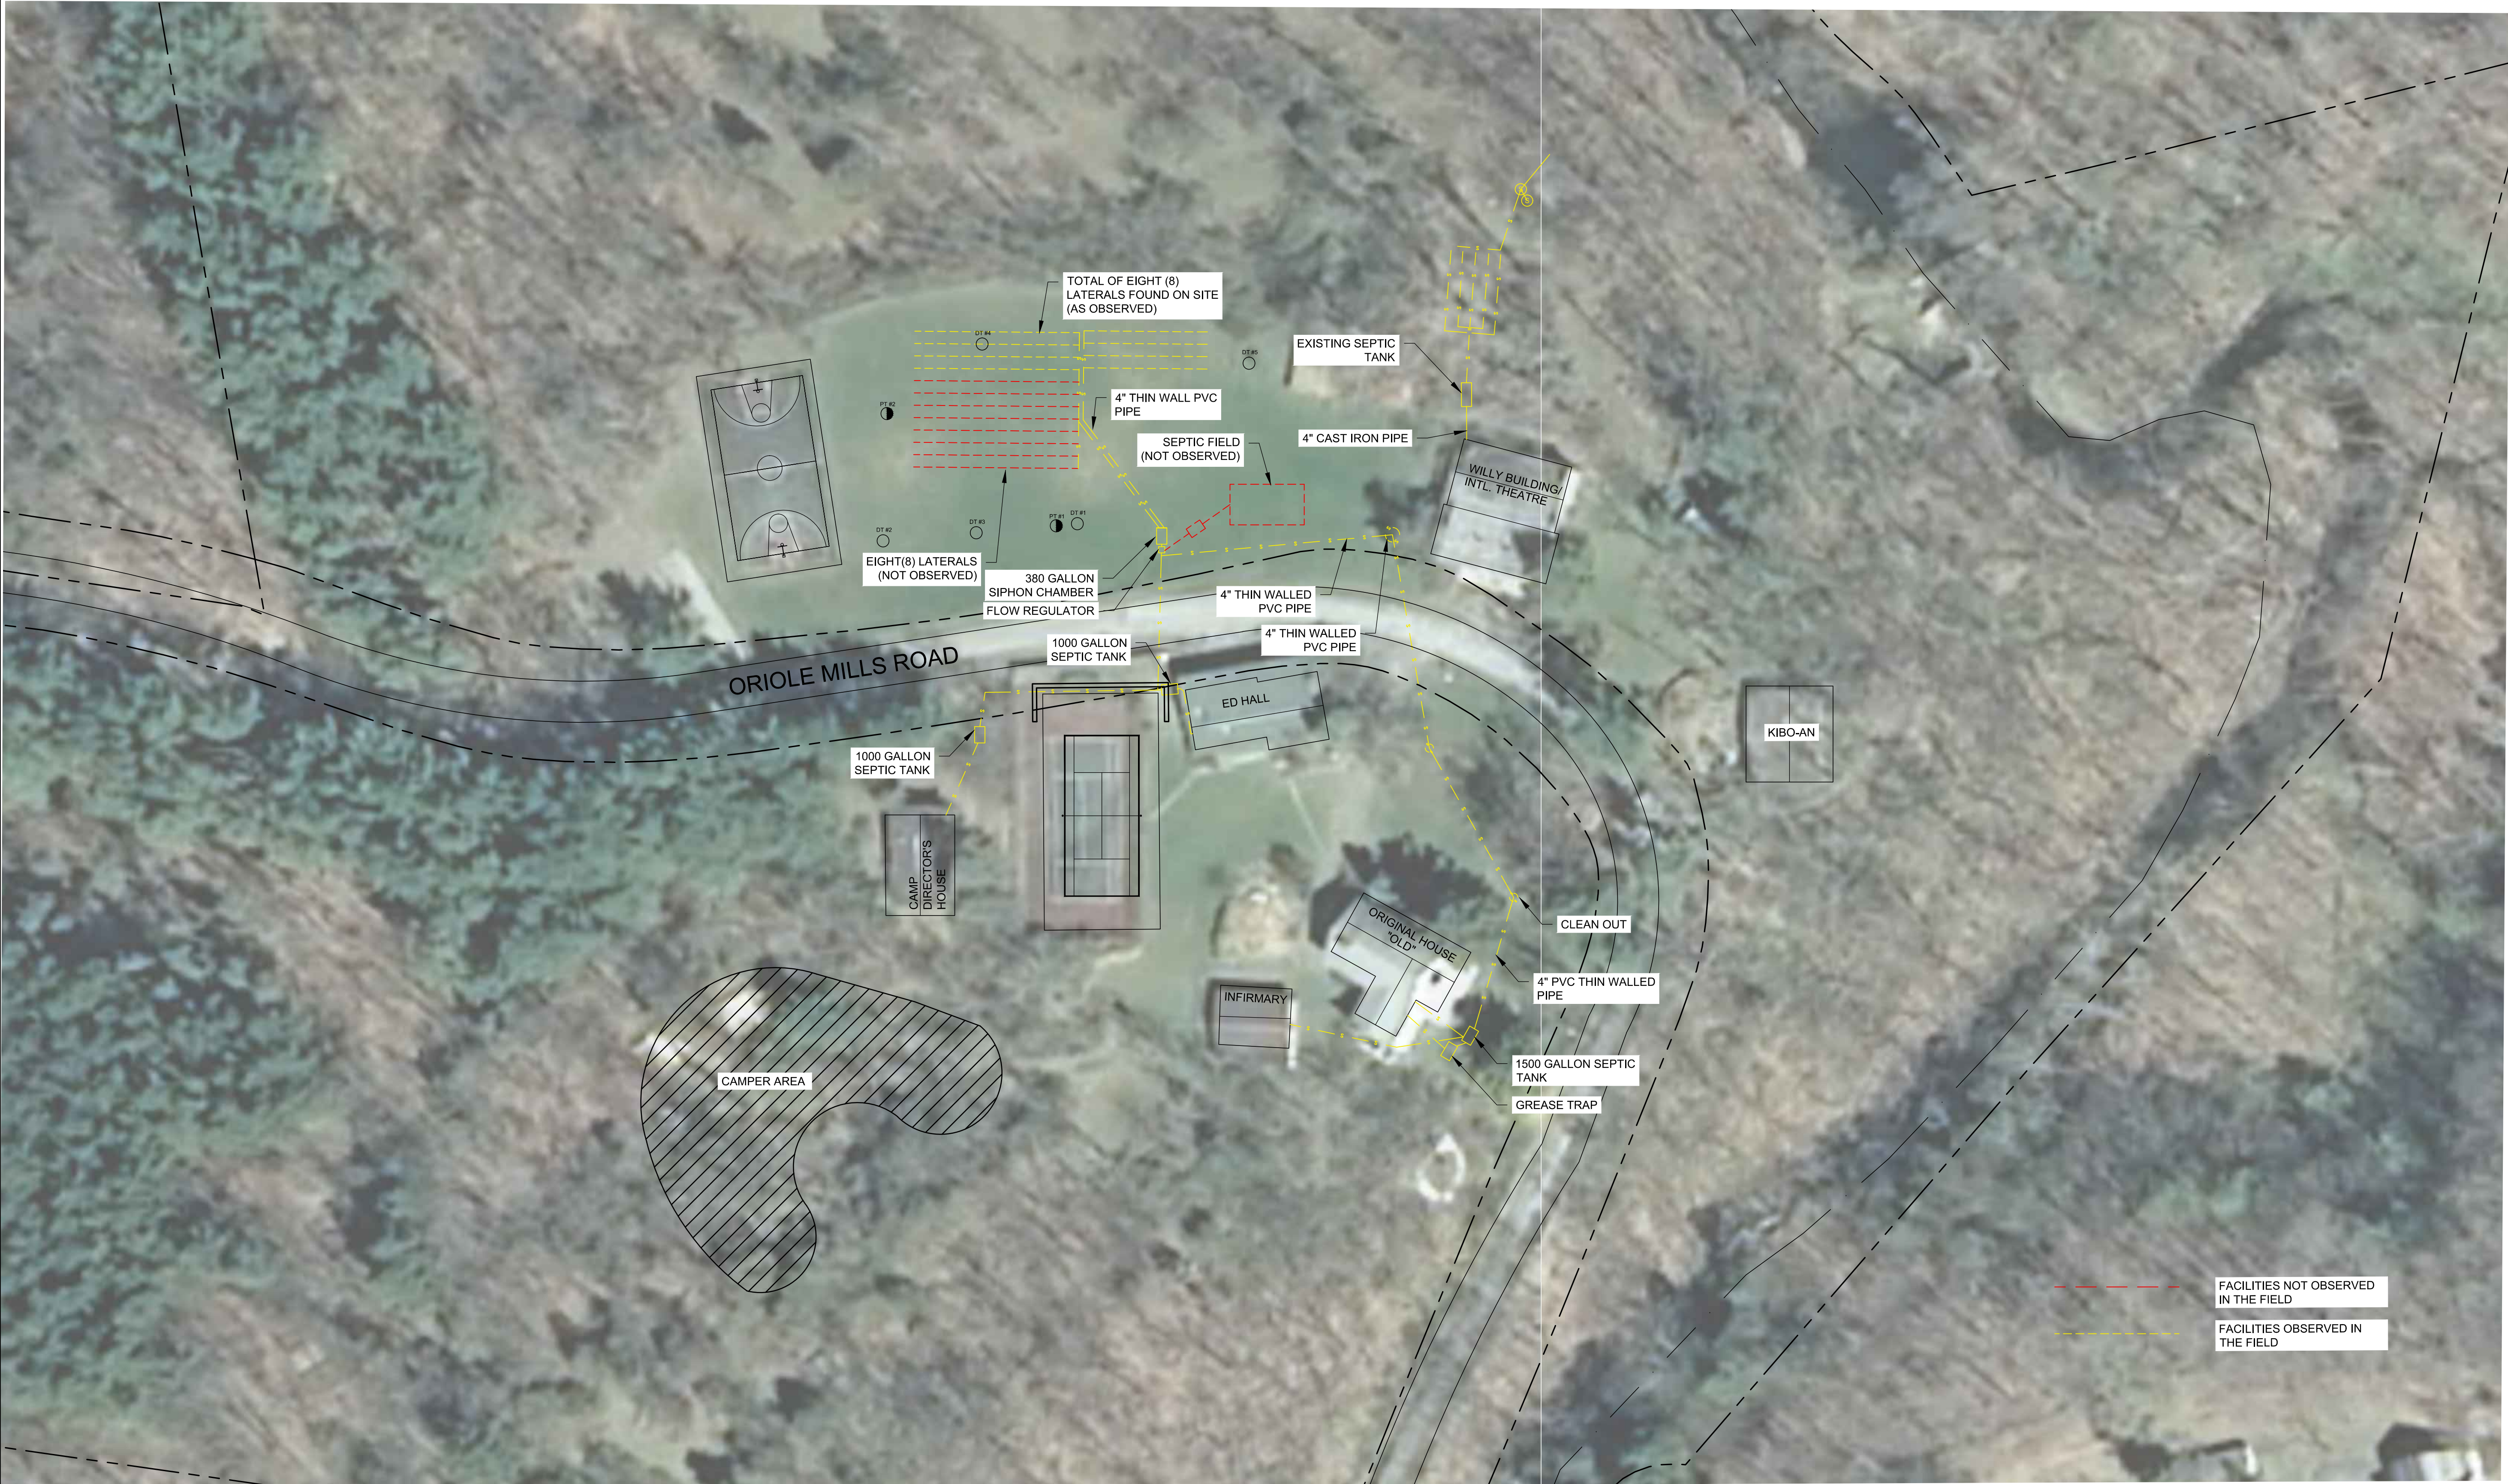
SEWER EXISTING CONDITIONS

- A smaller field is shown on the plans as having been built in the 1960s; however this field could not be located.
- A modified distribution box was located on south side of athletic field before siphon chamber. D-box is used to split flow between the two (2) fields. The structure is in poor condition and contains silt.

- A siphon dosing chamber was located. The concrete structure is in good condition but the bell syphons appear corroded. A large amount of silt was found in structure. Two (2) pipes were found leaving structure.

- Approximately 500 lf of absorption trench was located in the large septic field. An additional, 460 LF of trench, shown on the plans, was not observed on the southwest side of the field. Additional investigation may be required.

- Access covers were not provided to the structures making maintenance difficult.
- All 4" thin wall PVC pipe appears to be deteriorated. Material is brittle and cracks were found. Cracks in system are likely reducing the flow capacity of the absorption trenches.
