**IMPROVEMENTS & EXPANSION ASSESSMENT REPORT
CAMP RISING SUN CLINTON
TOWN OF CLINTON, ULSTER COUNTY, NEW YORK**

PREPARED FOR
Louis August Jonas Foundation
77 Bleecker Street, C2-13
New York, New York 10012

PREPARED BY
Crawford & Associates Engineering, P.C.
4411 Route 9, Suite 200
Hudson, New York 12534
&
PSA Studios
212 Main St #2B
Germantown, NY 12526

PREPARED
February 1, 2017
REVISED March 6, 2017

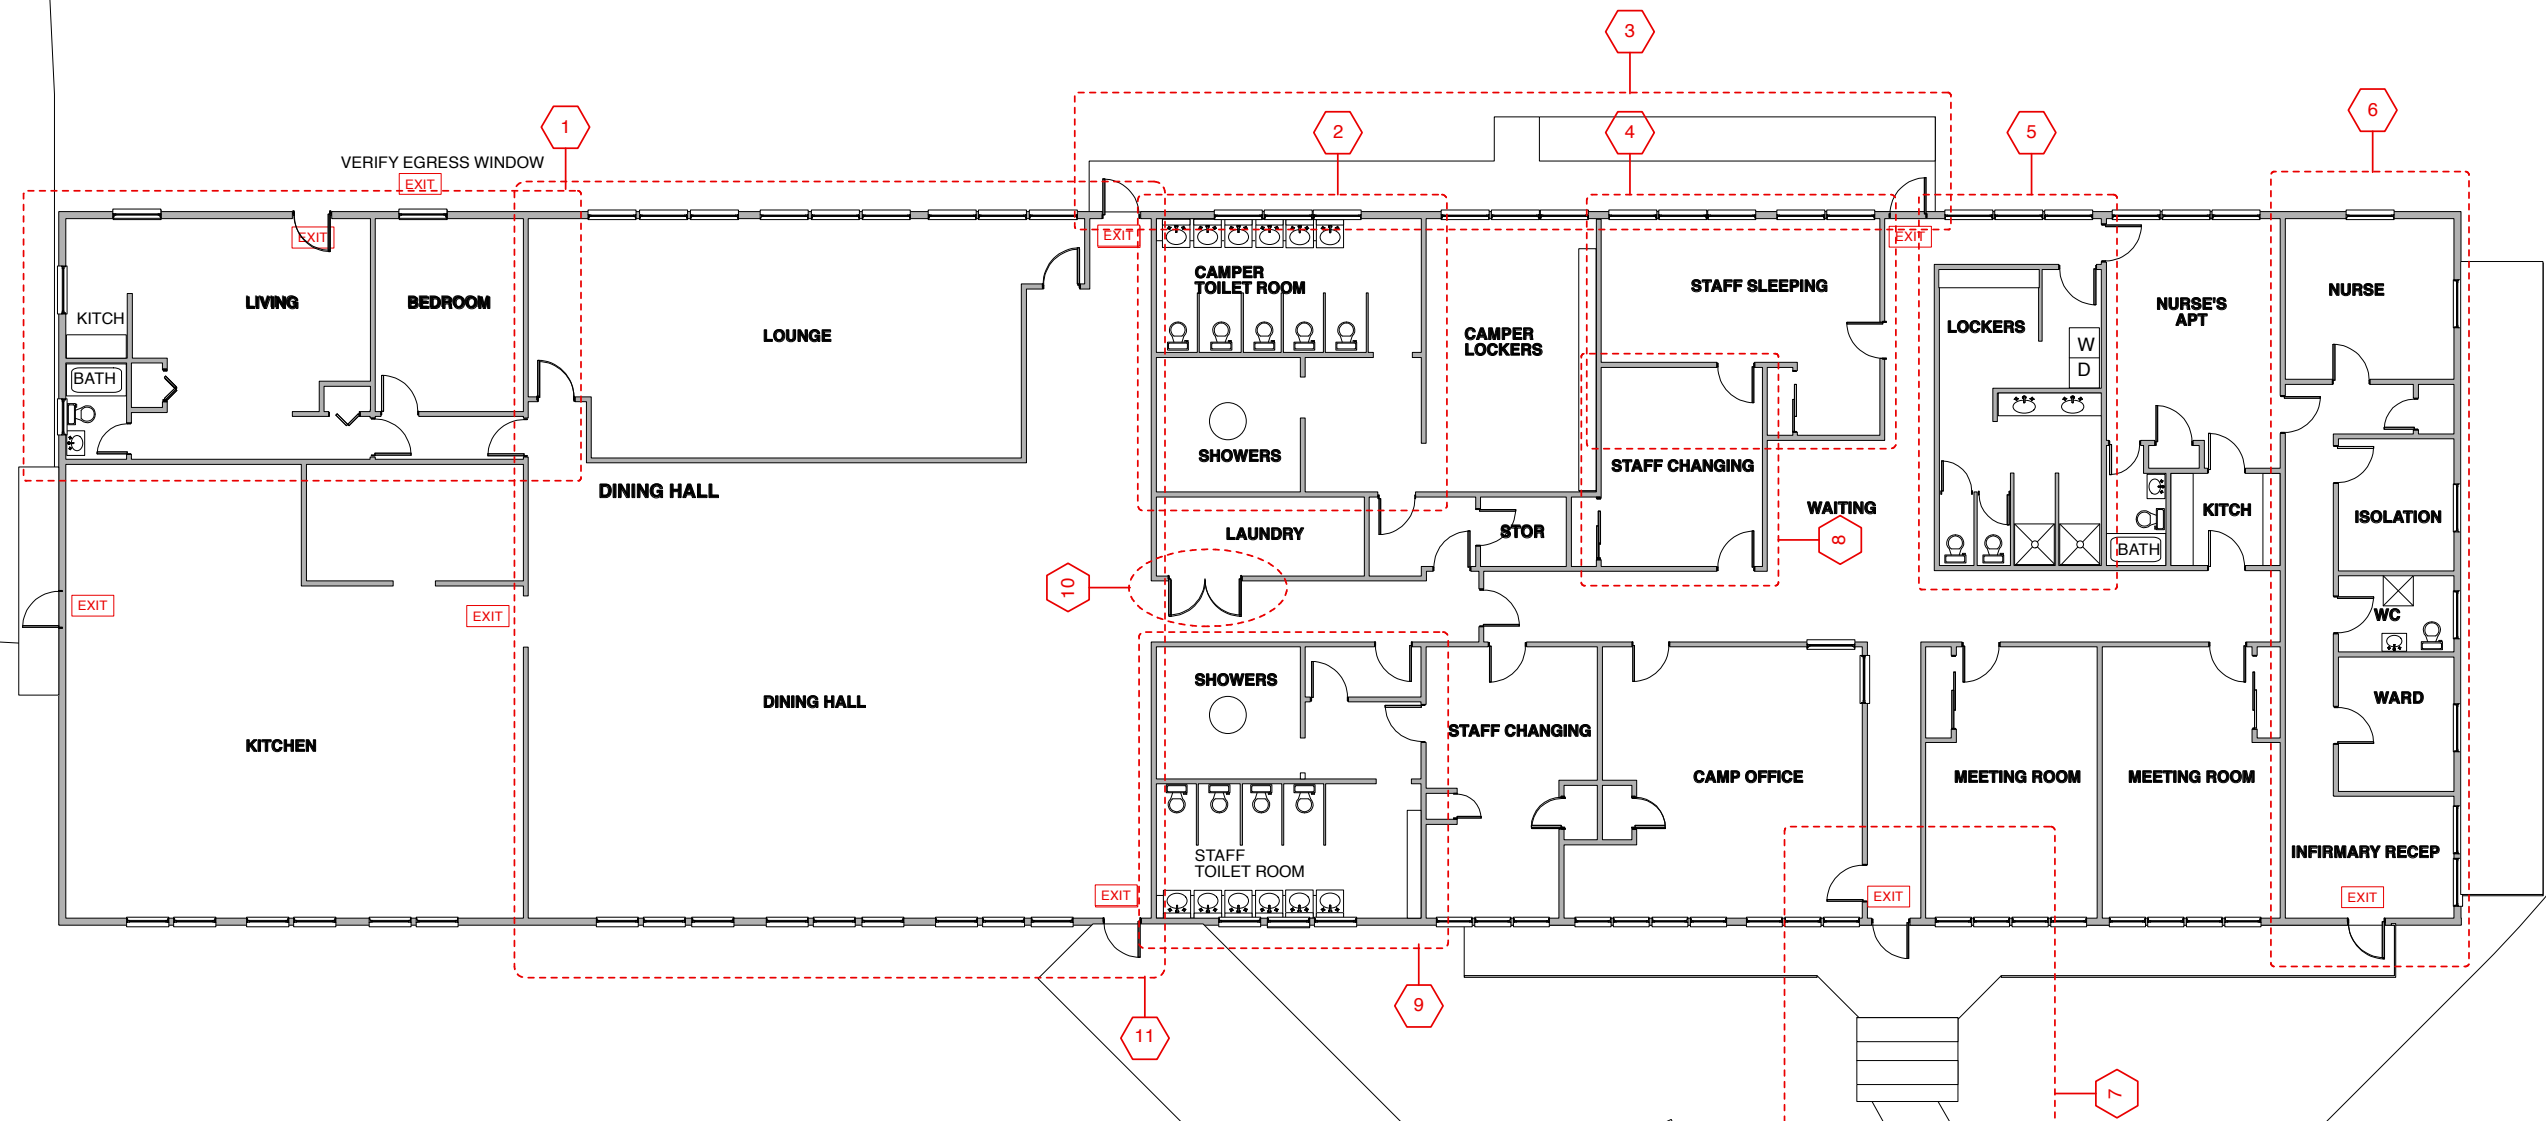
EXISTING MAIN BUILDING INTERIOR

LOCATION	CODE ISSUES:	IMPROVEMENTS REQUIRED	RECOMMENDATIONS
1	Per 508.3.3 2 hour fire separation required between R and A occupancies 1.5 hour door assembly required Bedroom requires egress window as second means of egress		Possible reconfiguration to add another bedroom Provide 2hour rated separation between residential unit and kitchen and dining area
2	No ADA accessible fixtures	Inadequate ventilation, excessive condensation Recptacles and fittings are rusting	Install proper ventilation per C&A Install new toilet room fittings Redesign to accomodate ADA requirements
3	Egress rails not to Code Ramp not ADA compliant	Ramp and stairs in poor condition Railing supports are failing	Remove ramp and stairs, replace with code compliant egress stairs and railings.
4	Per 508.3.3 2 hour fire separation required between R and A occupancies 1.5 hour door assembly required		Discontinue sleeping as a use

LOCATION	CODE ISSUES:	MAINTENANCE/REPAIR/REDESIGN REQUIREMENTS	REDESIGN REQUIREMENTS AND RECOMMENDATIONS
8		Staff changing rooms poorly located without direct access to showers and toilet areas. Limited privacy with direct opening to corridor	Reconfigire/relocate staff changing room
9	No ADA accessible fixtures	Inadequate ventilation, excessive condensation Group shower configuration is insufficient and lacks privacy	Install proper ventilation per C&A Redesign to accomodate ADA requirements Redesign showers
10	Laundry doors swing in to egress path	Inadequate ventilation, excessive condensation Location next to dining hall and main corridor is not good	Relocate laundry to a better location with proper ventilation.
11		Floor tiles need replacing Floor bounce should be addressed Because of limited ventilation the space gets too hot and stuffy Poor acoustics including noisy exhaust fans Poor access to exterior	Improve cross ventilation by removing partition and clerestory between dining hall and lounge. Doors to the exterior would improve ventilation and well as connection to exterior Install new flooring, possibly with softer material to improve acoustica Install acoustic material at the ceilings Provide improved and quieter mechanical ventilation

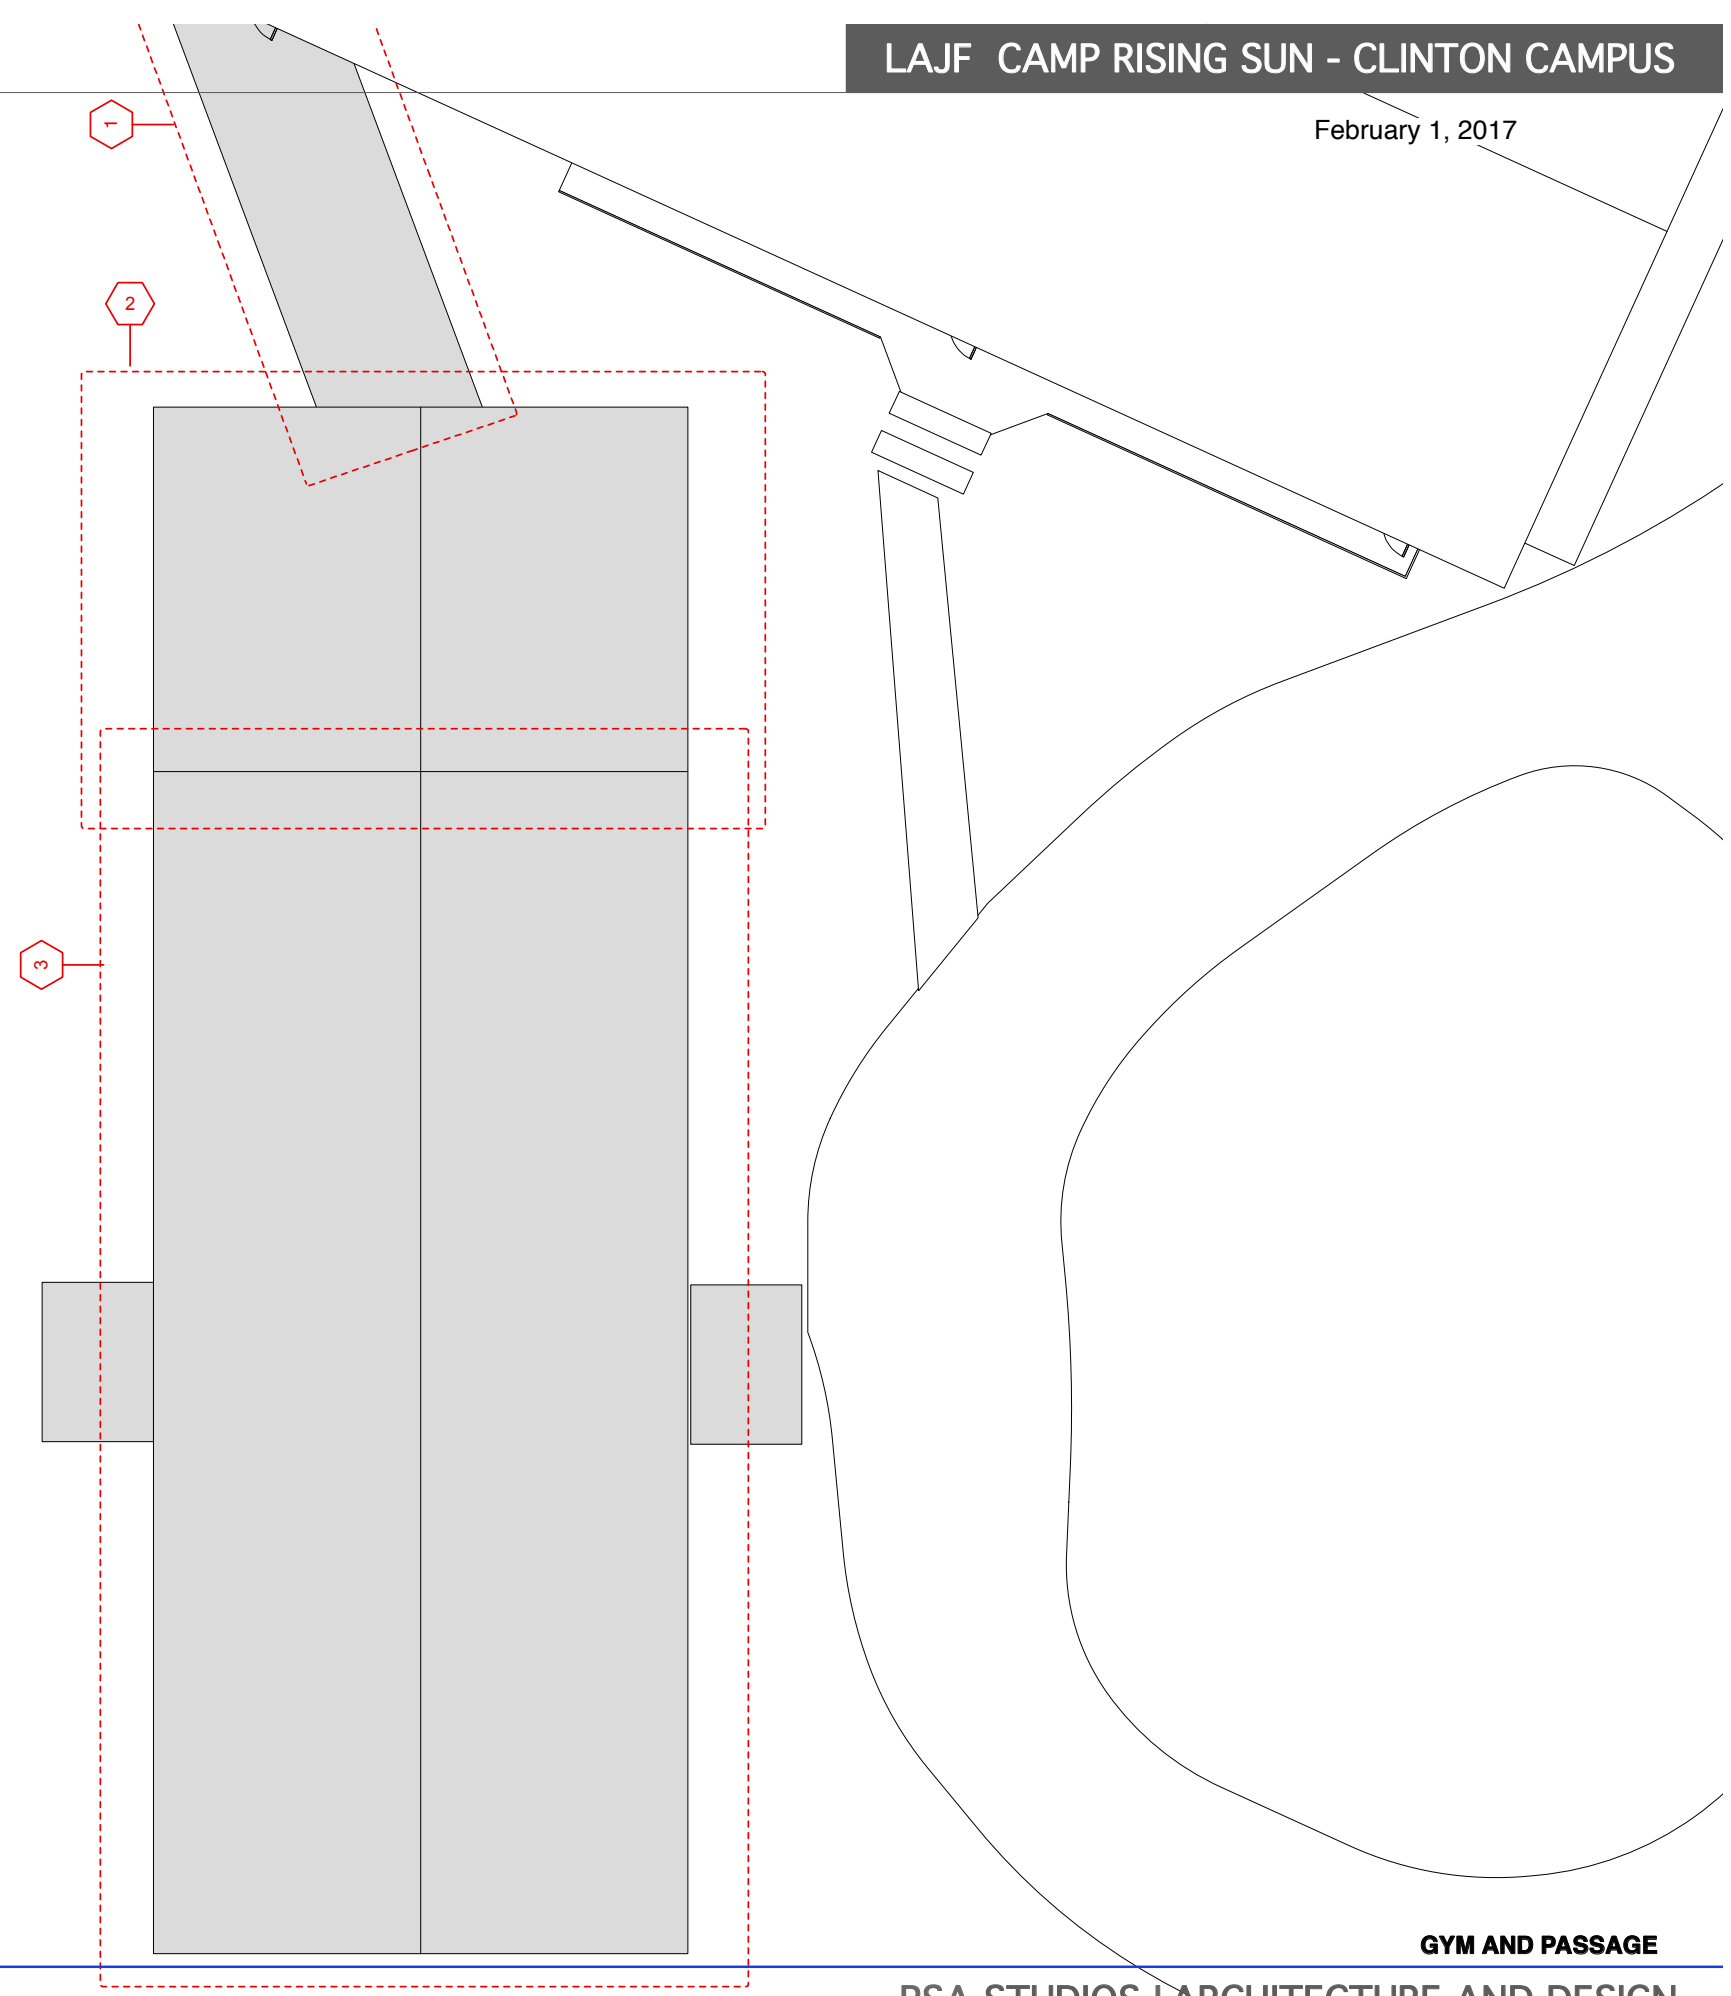
GYM AND PASSAGE

LOCATION	CODE ISSUES:	IMPROVEMENTS REQUIRED	RECOMMENDATIONS
1		Windows not operable	Replace windows
2		Insufficient space for full camp assembly Insufficient ventilation Floors damaged and scratched	Redesign and enlarge camper's lounge in to gym area Possible installation of new doors for improved ventilation and access to exterior Repair and refinish wood floors
3		Floor joists and sill rotted and failing at North side of building near the entry Interior panelling delaminating Panels at window openings are not weather tight Electrical distribution substandard and/or not code compliant per C&A Poor light and ventilation Exterior siding requires repair and painting	Redesign gym to allow for additional lounge space with possible mezzanine area above Remove and replace wall cladding. Coordinate with new wiring Create larger window openings with weatherproof covers to improve light and ventilation Install new doors at entry and opposite wall. Possibly rolling barn type doors to improve light and ventilation and connection to exterior Consider installing new exterior siding for improved maintenance and aesthetics.
