**IMPROVEMENTS & EXPANSION ASSESSMENT REPORT
CAMP RISING SUN CLINTON
TOWN OF CLINTON, ULSTER COUNTY, NEW YORK**

PREPARED FOR
Louis August Jonas Foundation
77 Bleecker Street, C2-13
New York, New York 10012

PREPARED BY
Crawford & Associates Engineering, P.C.
4411 Route 9, Suite 200
Hudson, New York 12534
&
PSA Studios
212 Main St #2B
Germantown, NY 12526

PREPARED
February 1, 2017
REVISED March 6, 2017

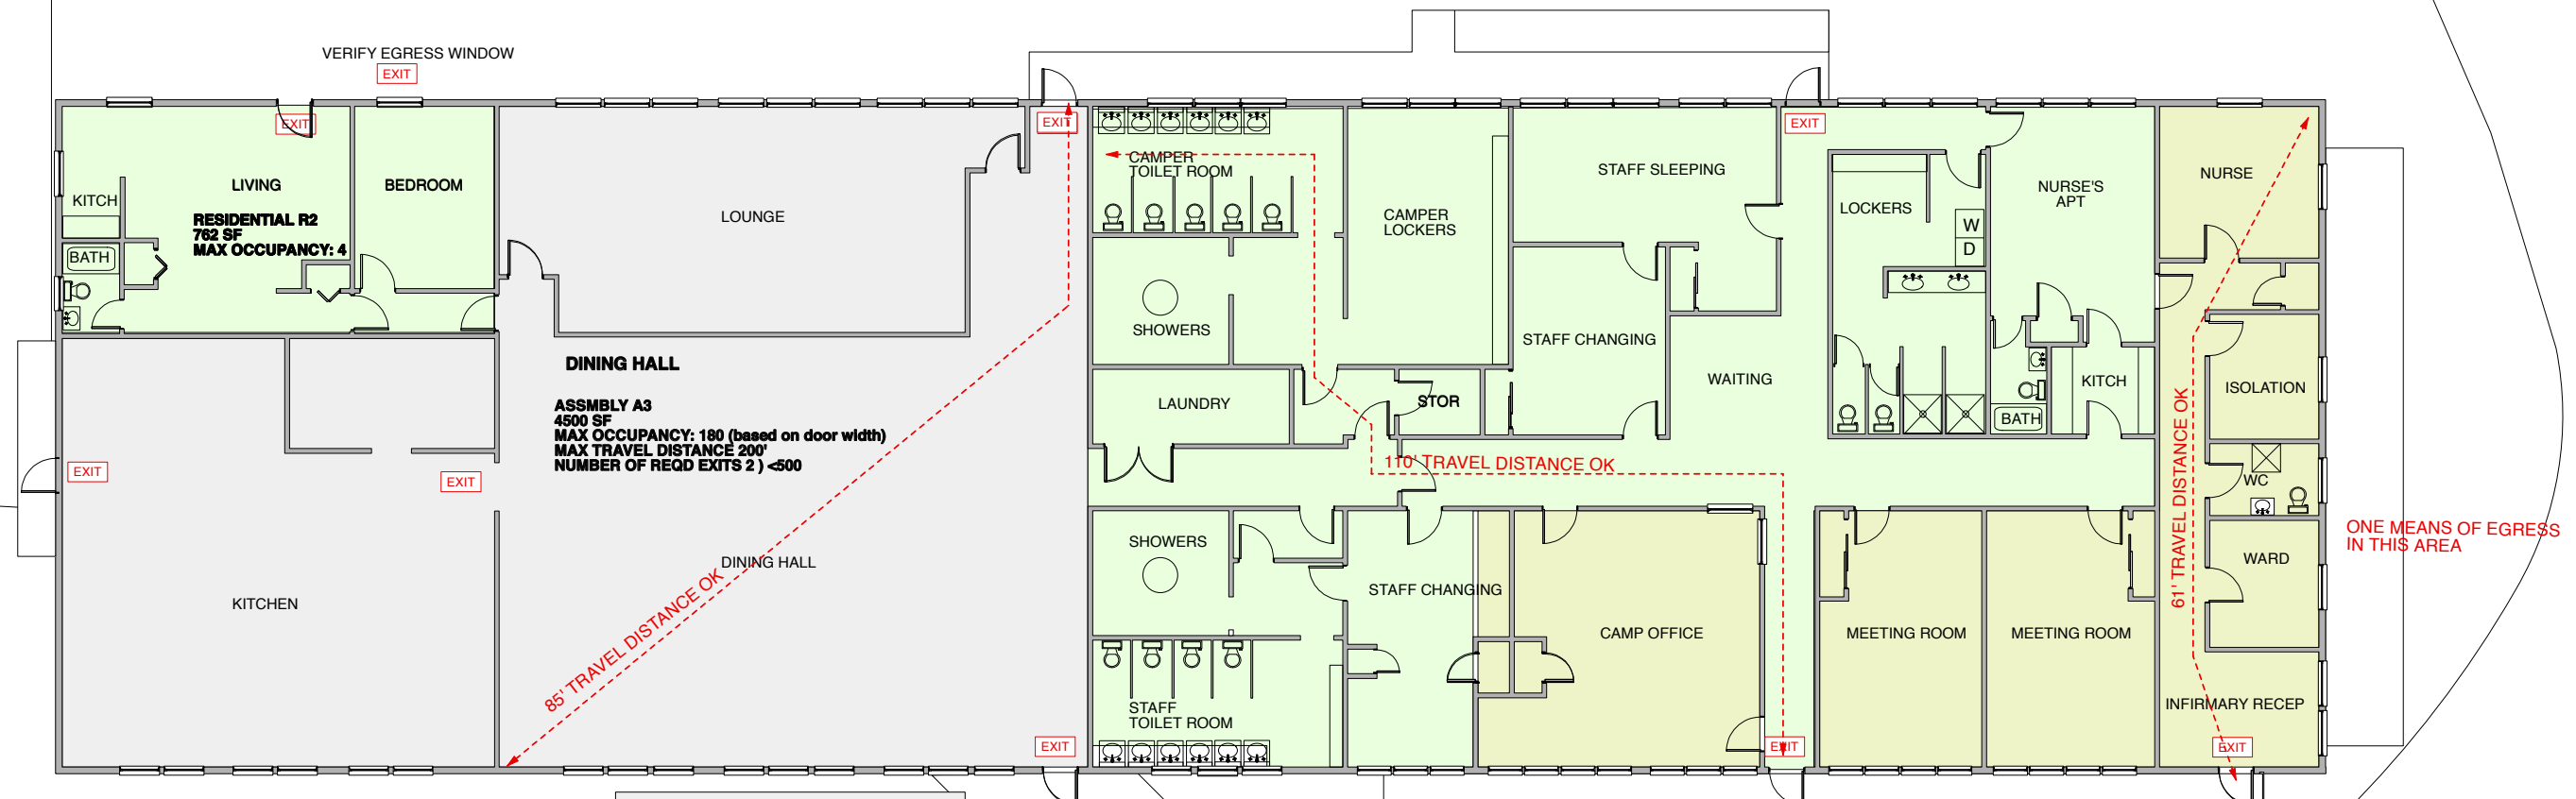
LOCATION	CODE ISSUES:	IMPROVEMENTS REQUIRED	RECOMMENDATIONS
1	Per 508.3.3 2 hour fire separation required between R and A occupancies 1.5 hour door assembly required Bedroom requires egress window as second means of egress		Possible reconfiguration to add another bedroom Provide 2hour rated separation between residential unit and kitchen and dining area
2	No ADA accessible fixtures	Inadequate ventilation, excessive condensation Recptacles and fittings are rusting	Install proper ventilation per C&A Install new toilet room fittings Redesign to accomodate ADA requirements
3	Egress rails not to Code Ramp not ADA compliant	Ramp and stairs in poor condition Railing supports are failing	Remove ramp and stairs, replace with code compliant egress stairs and railings.
4	Per 508.3.3 2 hour fire separation required between R and A occupancies 1.5 hour door assembly required		Discontinue sleeping as a use

5	No ADA accessible fixtures	Inadequate ventilation, excessive condensation Finishes and fixtures inadequate	Install proper ventilation per C&A Redesign to accomodate ADA requirements Redesign to accomodate single gender staff.
6	Only one means of egress from area. Egress through bedroom not allowed		Provide additional means of egress
7	Stair and walkway railings not to Code	Existing railings are failing Concrete walkway in poor condition Roof overhang spills water on to stairs and walkway creating dangerous and slippery condition.	Repair walkway, coping and nstall Code compliant railings. Redesign the roof overhang to extend over walkway Consider design improvements to the entry area in general

LOCATION	CODE ISSUES:	MAINTENANCE/REPAIR/REDESIGN REQUIREMENTS	REDESIGN REQUIREMENTS AND RECOMMENDATIONS
8		Staff changing rooms poorly located without direct access to showers and toilet areas. Limited privacy with direct opening to corridor	Reconfigire/relocate staff changing room
9	No ADA accessible fixtures	Inadequate ventilation, excessive condensation Group shower configuration is insufficient and lacks privacy	Install proper ventilation per C&A Redesign to accomodate ADA requirements Redesign showers
10	Laundry doors swing in to egress path	Inadequate ventilation, excessive condensation Location next to dining hall and main corridor is not good	Relocate laundry to a better location with proper ventilation.
11		Floor tiles need replacing Floor bounce should be addressed Because of limited ventilation the space gets too hot and stuffy Poor acoustics including noisy exhaust fans Poor access to exterior	Improve cross ventilation by removing partition and clerestory between dining hall and lounge. Doors to the exterior would improve ventilation and well as connection to exterior Install new flooring, possibly with softer material to improve acoustica Install acoustic material at the ceilings Provide improved and quieter mechanical ventilation

ASSMBLY A3
 4500 SF
 MAX OCCUPANCY: 180 (based on door width)
 SHOULD BE POSTED FOR ACTUAL
 MAX TRAVEL DISTANCE 200'
 NUMBER OF REQD EXITS 2) <500

**RESIDENTIAL R2
 W/ ACCESSORY OFFICE
 AND TOILET ROOMS**
 6500 SF
 MAX OCCUPANCY PER
 APPROVED PLANS: 53
